USAAML TECHNICAL REPORT 64-13

CYCLOIDAL CAM TRANSMISSION

PHASES II AND III

CONTRACT DA 44-177-TC-651
WESTERN GEAR CORPORATION
SYSTEMS MANAGEMENT DIVISION

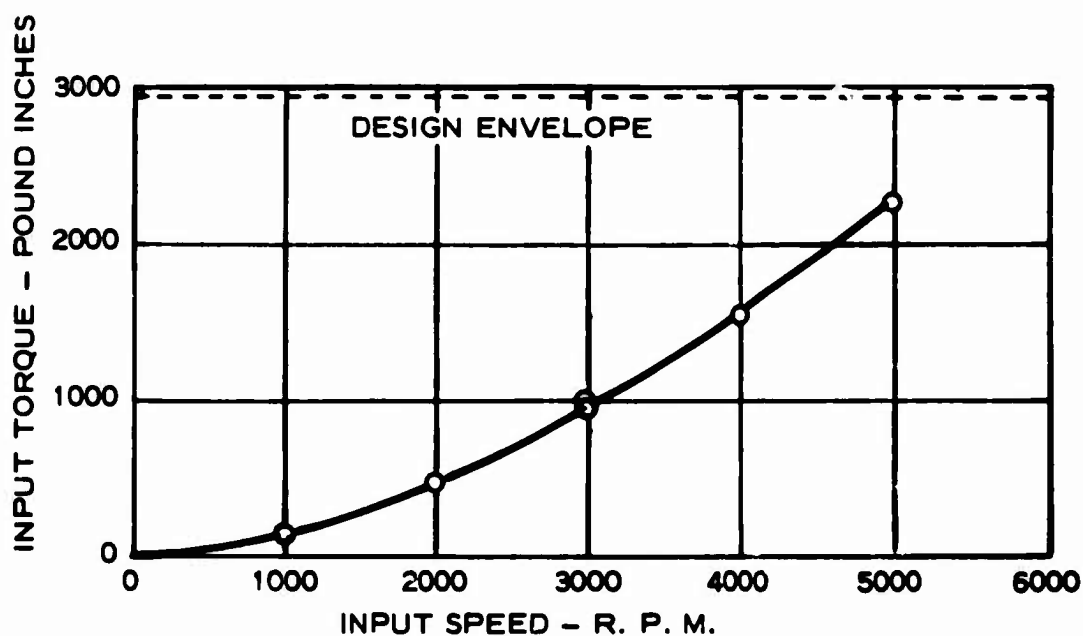
Figure 32. Input torque. Load testing with two stage water pump 3 x 4 x 11-1/2. Torque measured with 33 β_D transducer.

Figures 31, 32, 33 and 34 pages 39 and 40, are torque curves generated from transducer data. Special attention is directed toward the transducers. The two transducers were developed specifically for this application. While commercial transducers now on the market could also have generated the same data, the βD transducers

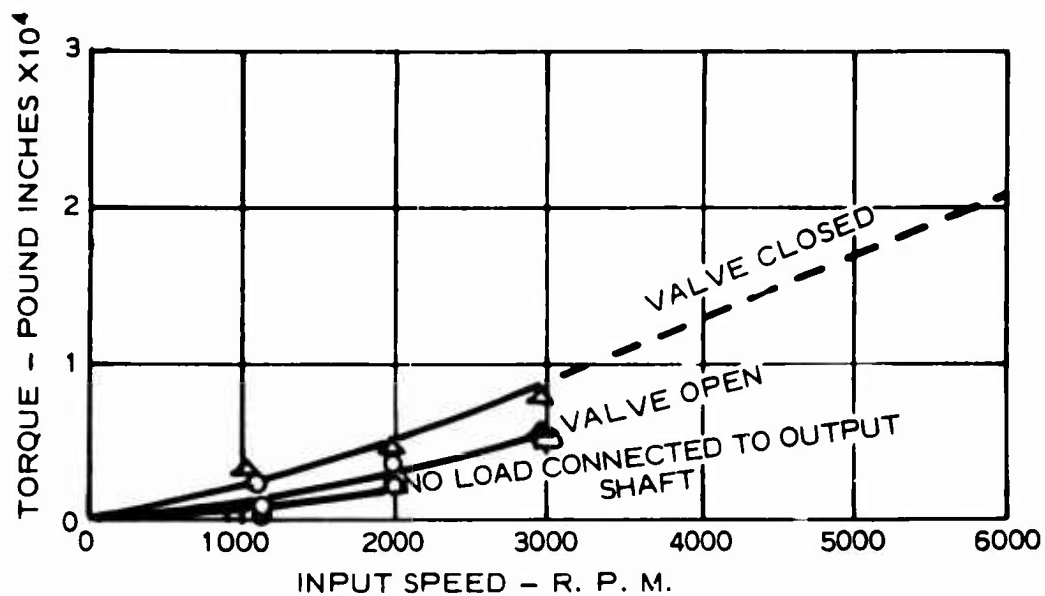
Figure 33. Output torque. Load testing with water pump 2 x 3 x 10-1/2 H-SMU. Torque measured with $64 \beta_D$ transducer.

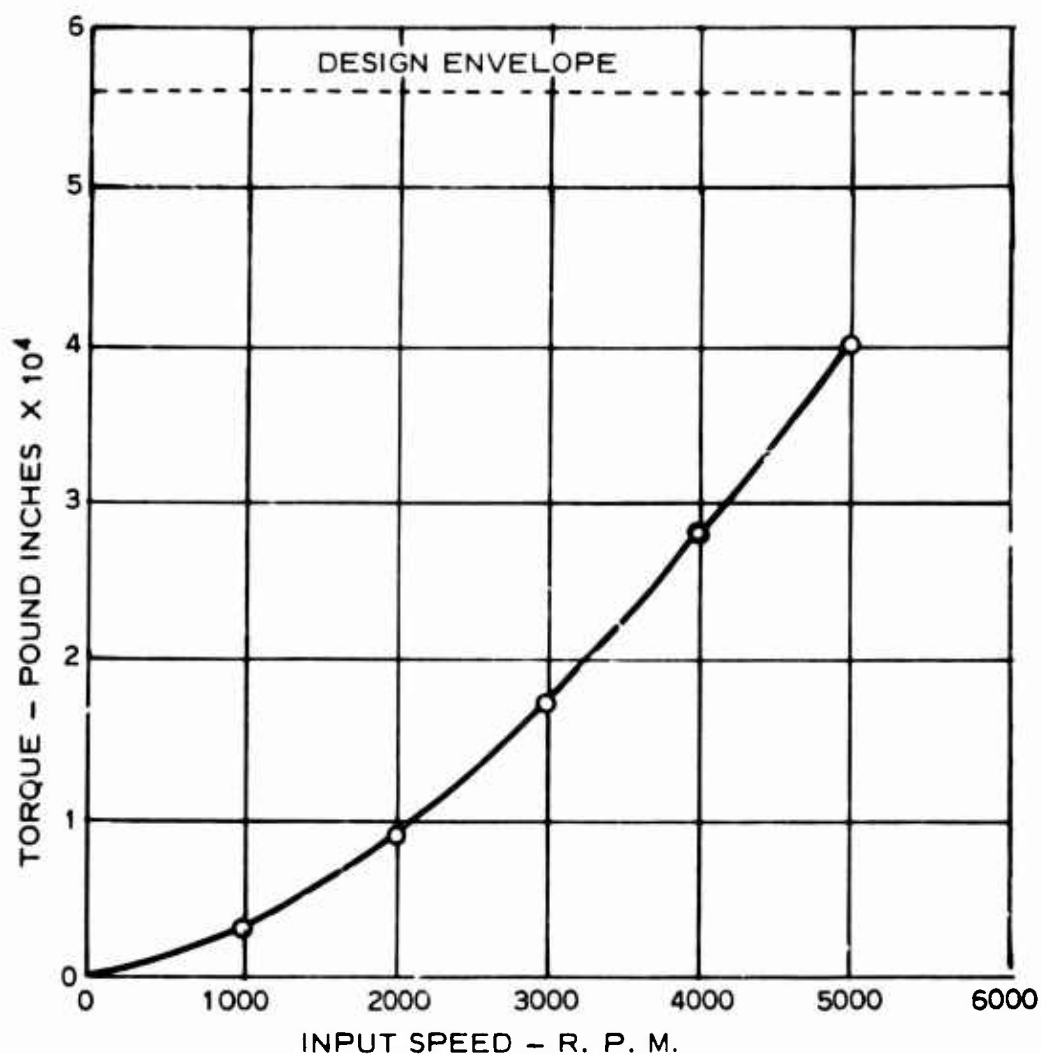
Figure 34. Output torque. Load testing with two stage water pump 3 x 4 x 11-1/2. Torque measured with $64 \beta_D$ transducer.

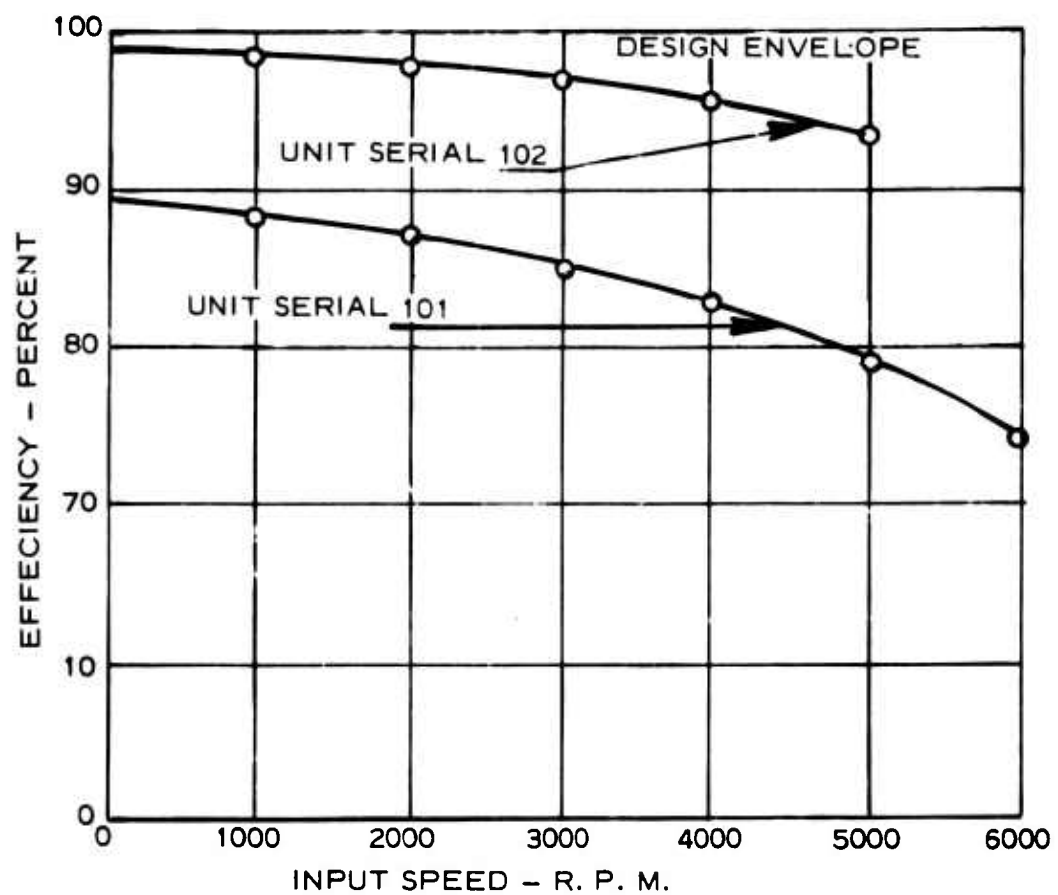
Figure 35. Comparison of efficiency under various loads and speed conditions.

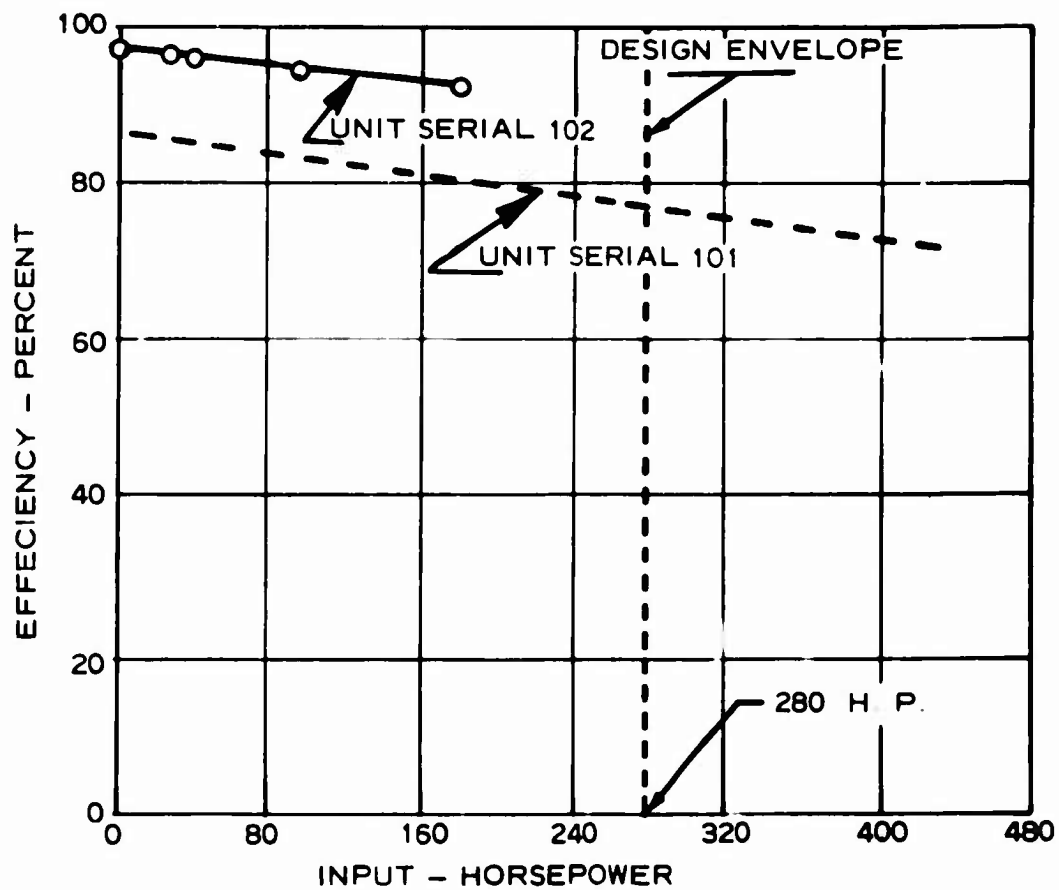
Figure 36. Comparison of efficiency with variable power conditions. Load testing with two stage water pump 3 x 4 x 11-1/2.

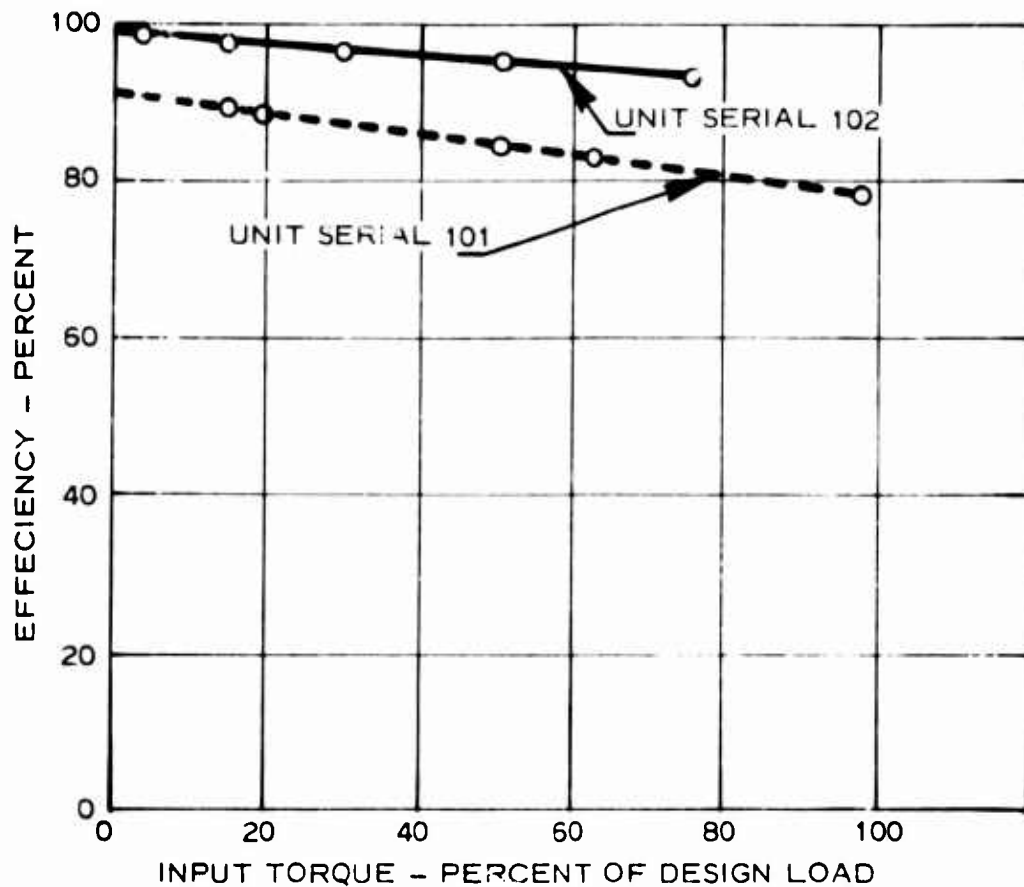
Figure 37. Comparison of efficiency with variable torque load testing with two stage water pump 3 x 4 x 11-1/2.

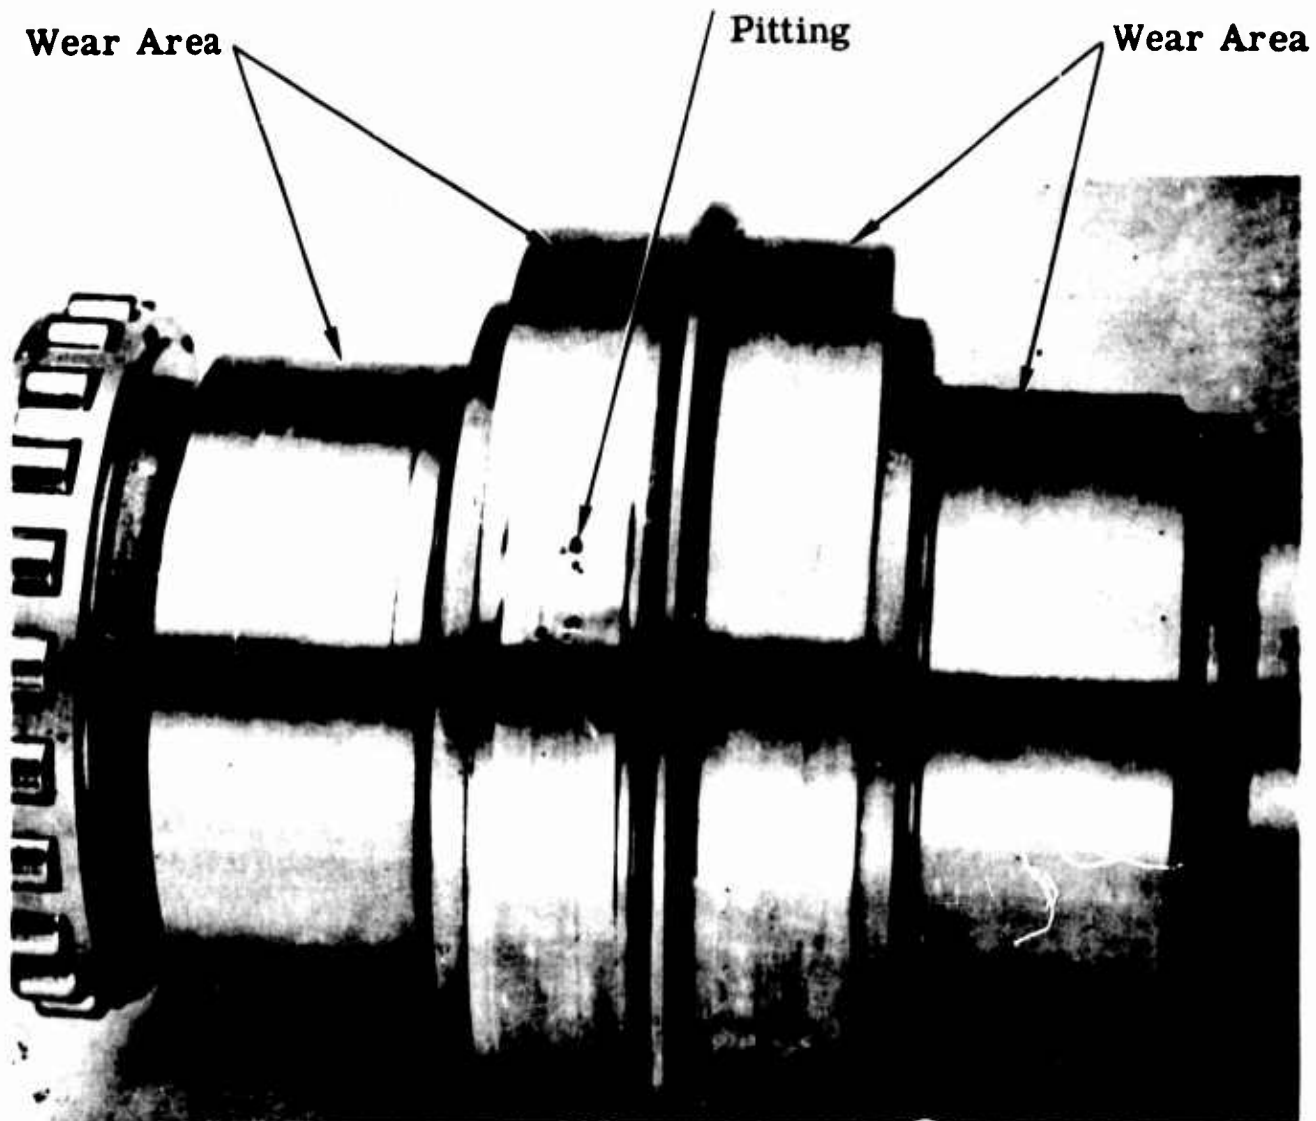
Figure 38. Crank shaft for transmission S/N 102 showing wear pattern from roller bearings.

Metallic particles were discovered in the oil filter after 17-1/2 hours of test running on transmission S/N 102, the test stand was shut down. Upon disassembly of the transmission and visual inspection of the crank shaft throws at all four cam plate positions showed heavy wear. It might be noted that this type of heavy wear was non-existent with transmission S/N 101.

Further examination of the balance of the component parts of S/N 102 were in satisfactory condition. The heavy wear on the crank shaft is shown in Figure 38 on page 45. Metallurgical and X-ray tests of the crank shaft indicate an adequate amount of structure and sufficient hardness for the roller bearings. The crank shaft was sectioned for detail metallurgical examinations.

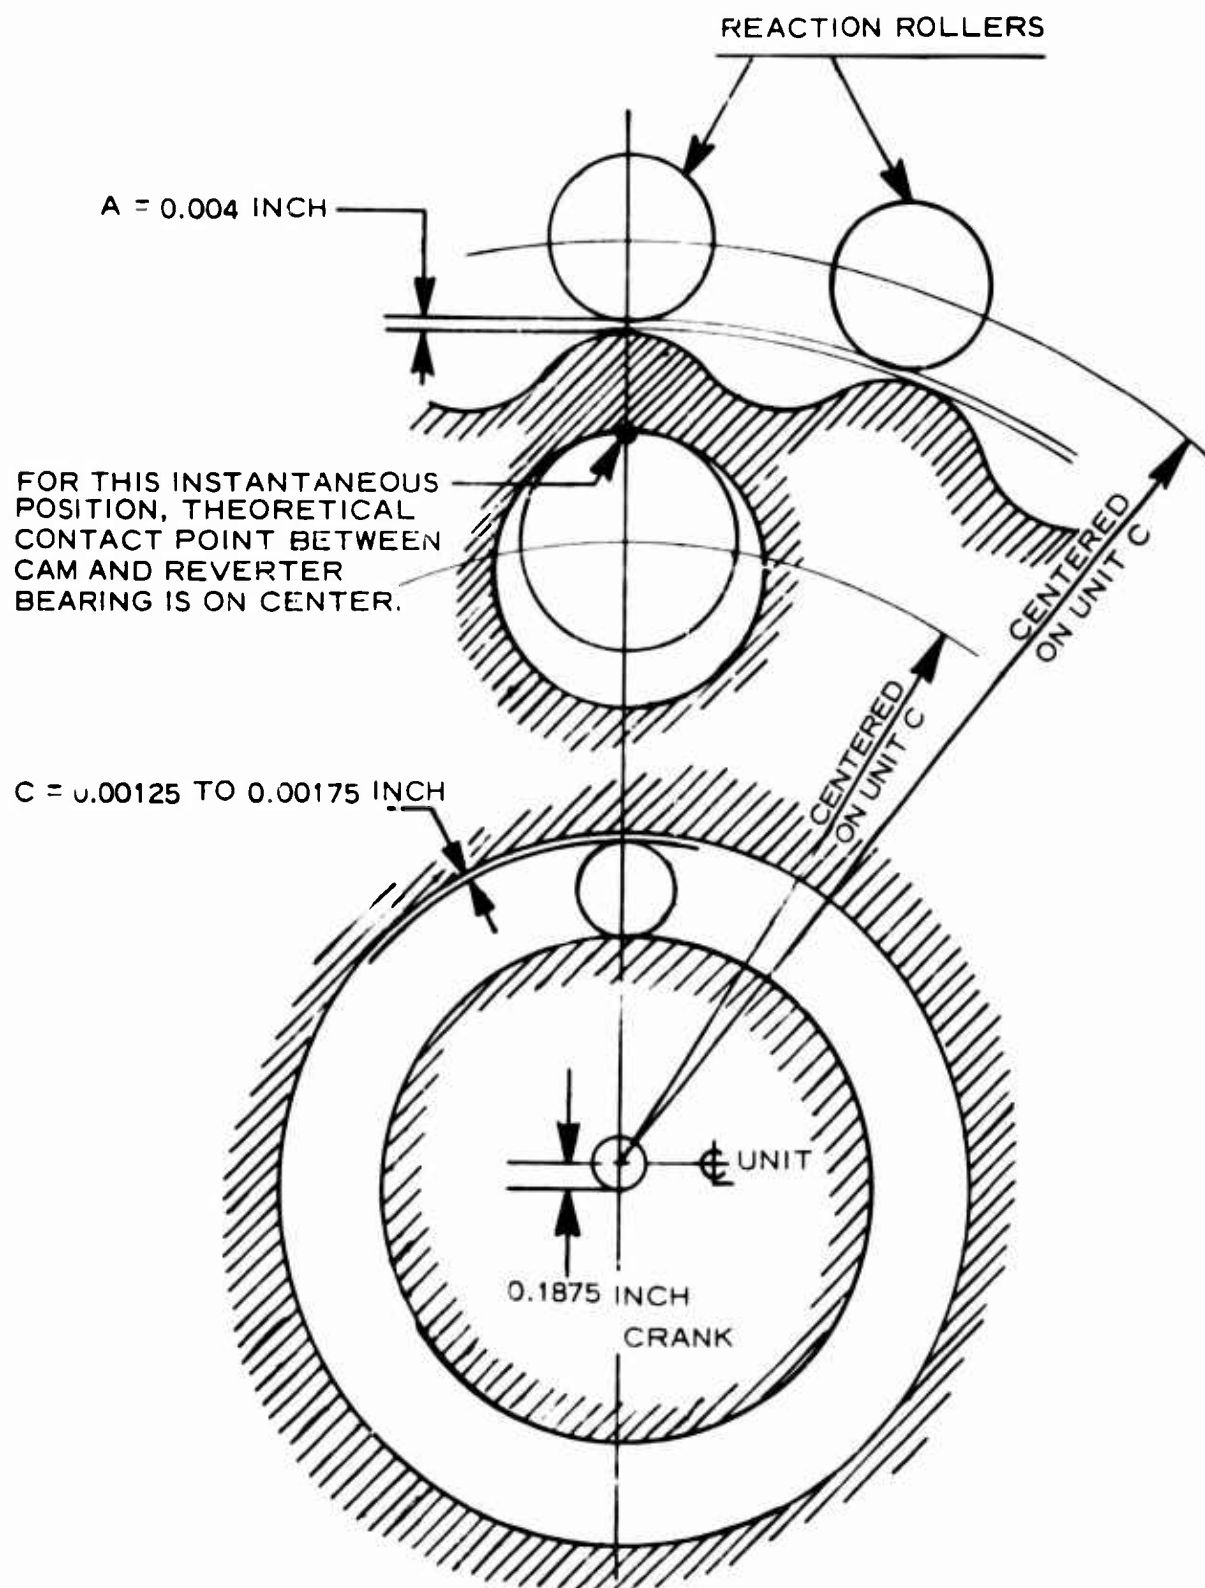
Figure 40. Bearing Clearances in Relation to Cam Plate in At "Rest" Position.

Typically, when drive load reaction is present, the cam plates are forced to oscillate around the reverter rollers in an offset condition with respect to the crankshaft. The rigidity of the reverter pins maintains the offset condition and thus the cam plate and crankshaft "orbits" interfere.

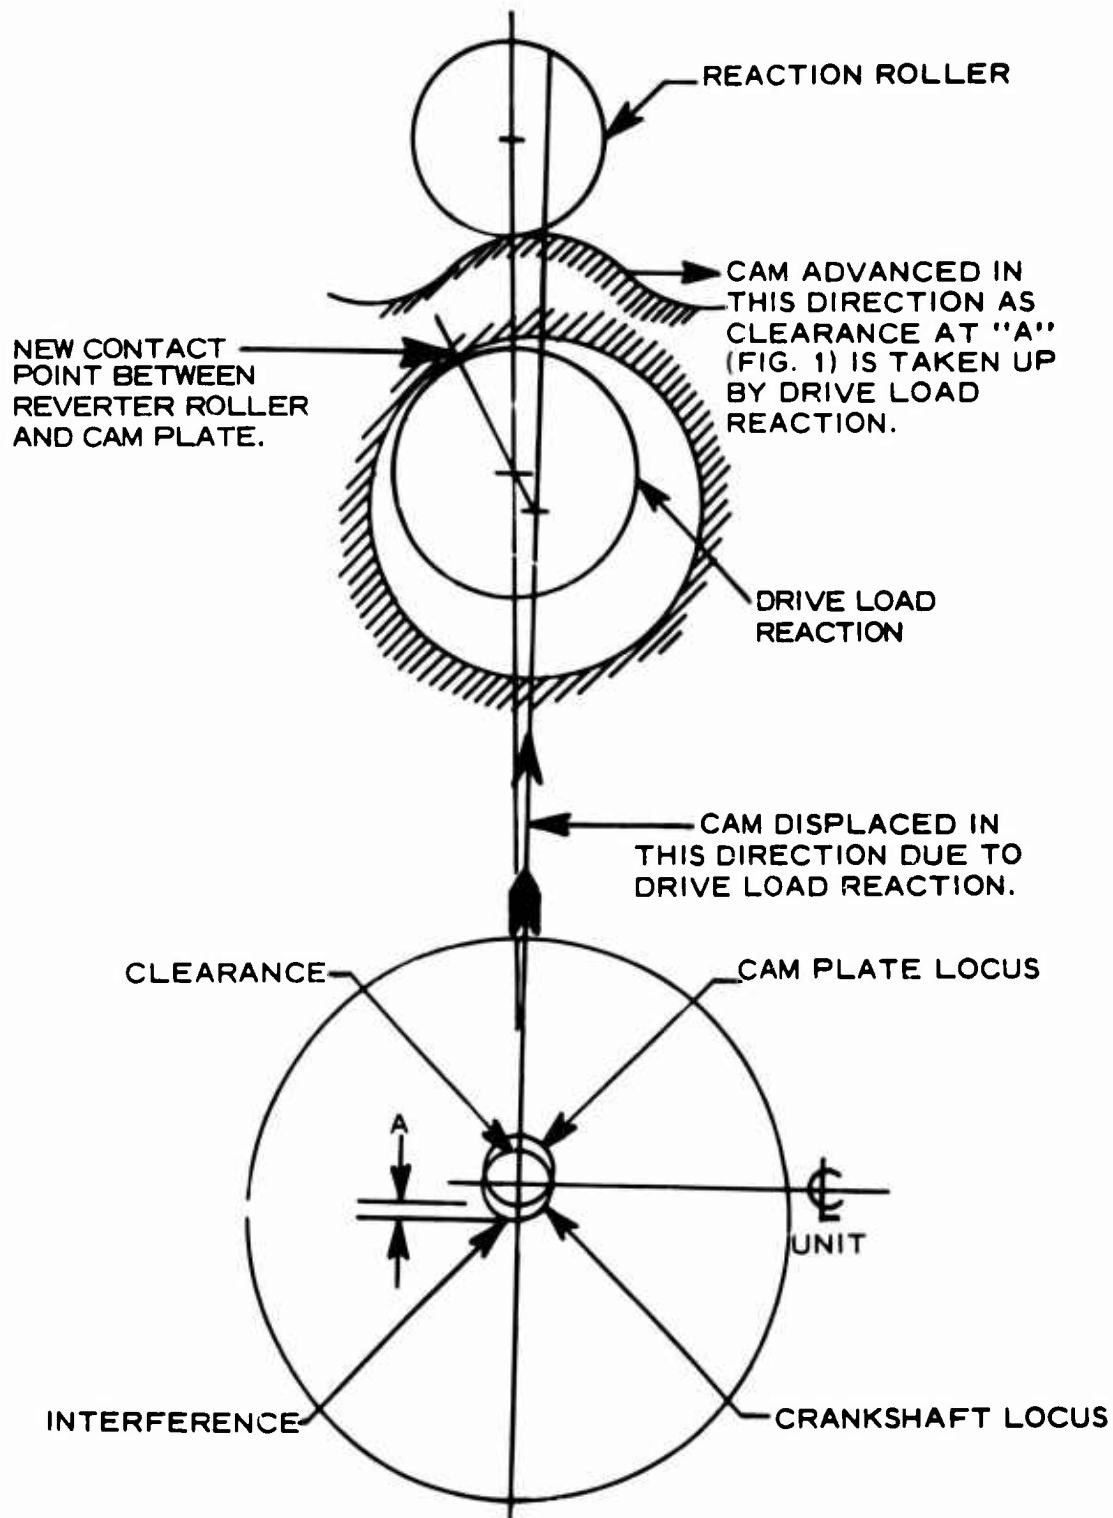
Figure 41. Displacement of Cam Plate in The "Running"/Operating Position.

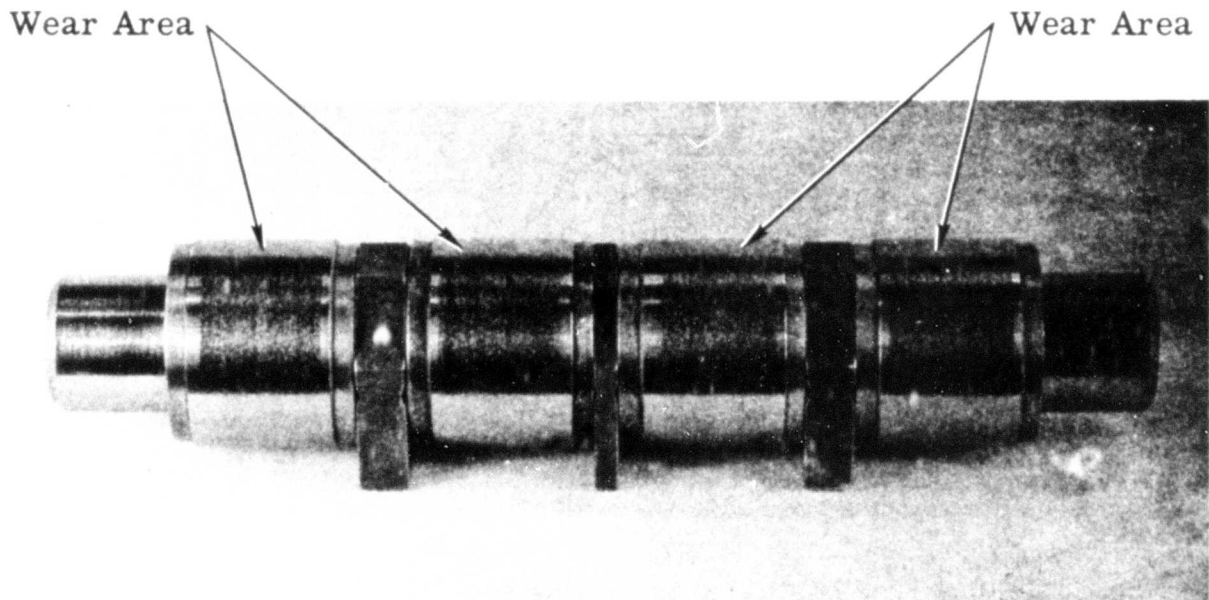
Figure 42. Fixed pin rollers from transmission S/N 102 showing skidding and scuffing.

Clearance "A" may be reduced by plating the reaction rollers (Figure 42).

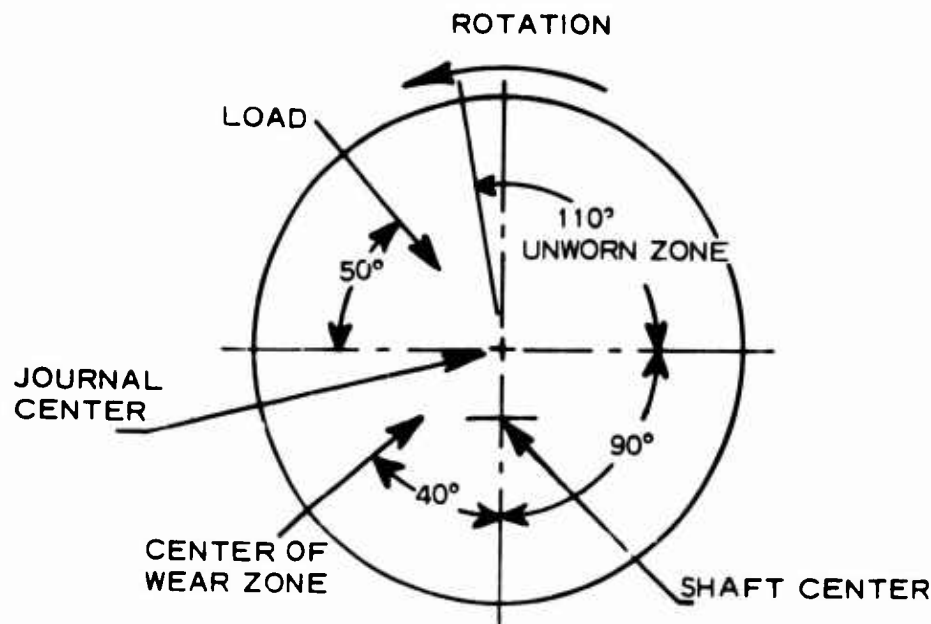
Figure 43. Loading and wear zones for crankshaft.

Since the severe wear occurred on the crankshaft bearing inner race and none on the outer race, a study was made on the inner and

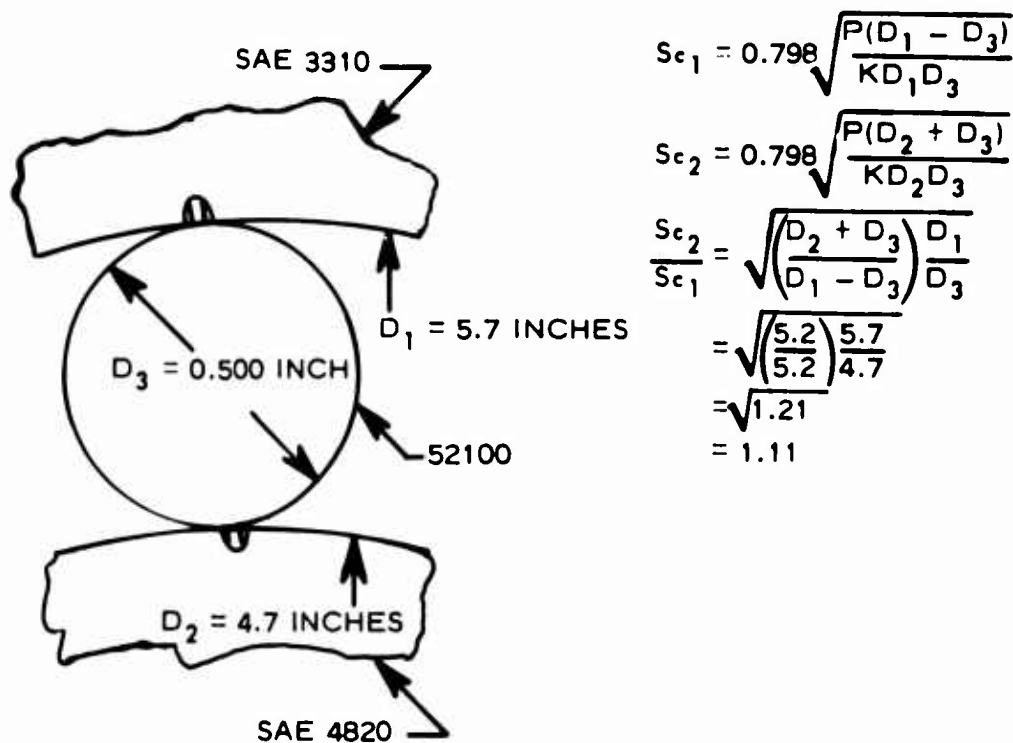
Figure 44. Roller crank bearing Hertz (contact) Stress ratio relationship.

The outer surface of the cylinder which rubs on the test specimen is a Timken cup T-54148, composed of 52100 steel. Approximately cubical wear specimens were cut from the crankshaft and cam plate. The bearing rollers fit into the machine with little alteration. Load weights were adjusted to compensate for the different curvatures of the rollers, cam lobes, and crankshaft, so that 100,000 p.s.i. contact stress was maintained, (Figure 44, page 53).

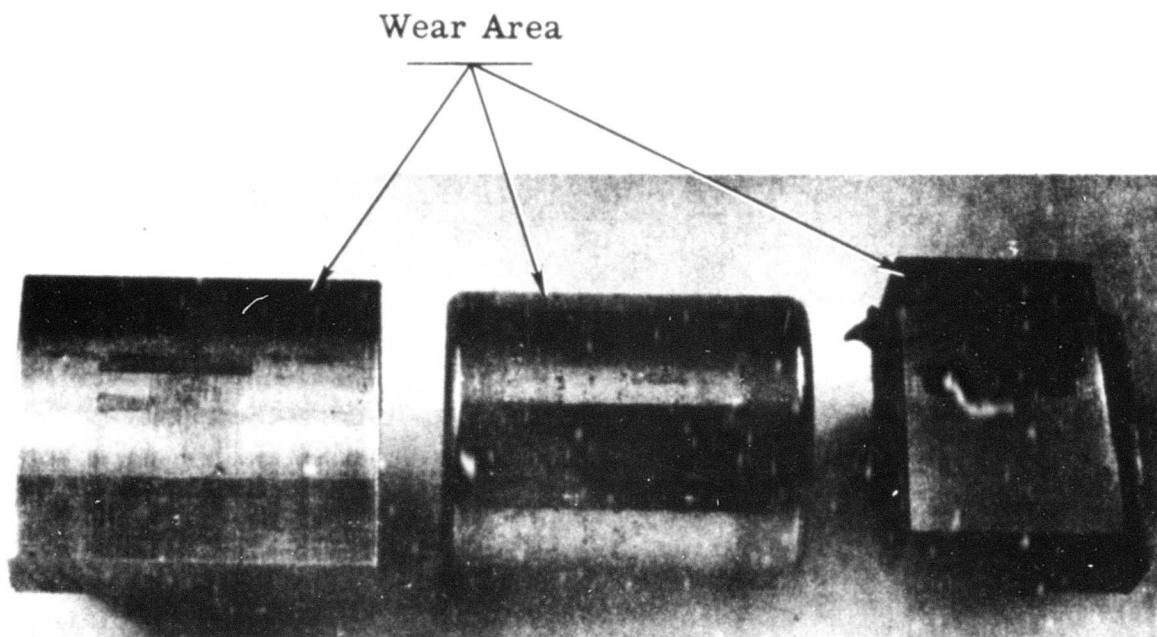
Figure 45. Wear test specimens with normal wear patterns from a cam plate, crank roller bearing, and the crankshaft.

- A. No significant difference was noted between the wear of the crank and of the cam plate.
- B. Bearing rollers seemed to wear slightly less than either of the above members.
- C. In all cases, the wear patterns due to sliding did not resemble the smooth, polished appearance of the worn crankshaft.

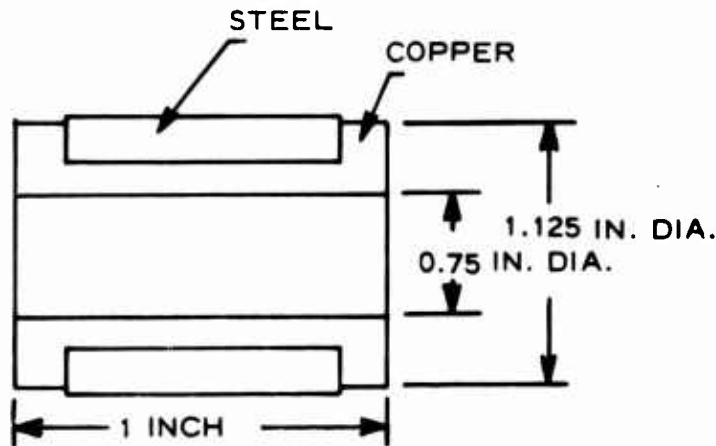
$I = \text{Moment of Inertia} = .98 \times 10^{-4} \text{ lbs-in-sec}^2$
Calculation of Net Tractive Force

3. Calculation Relevant to Wear on the Outer Lobes of the Cam Plate
 - a. In Figure 46 a calculation is shown of the net tractive force necessary to accelerate the outer rollers from rest to 6,000 r.p.m. in the time required for the abraded zone to pass by. This tractive force is the net force after friction with its supporting pin accounted for.

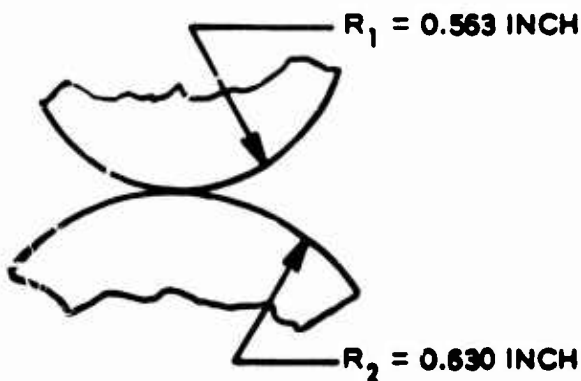
Figure 47. Contact stresses for fixed pin rollers.

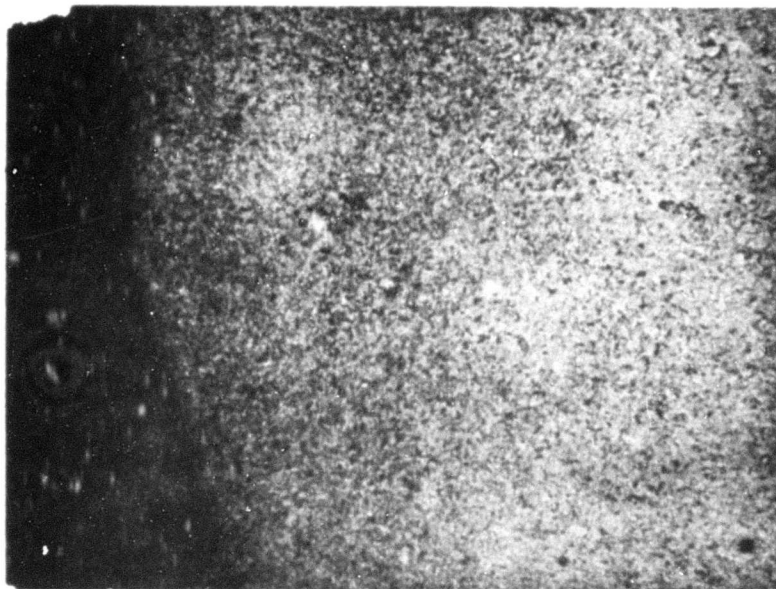
Figure 48. Transition area between worn and unworn surfaces. 100X

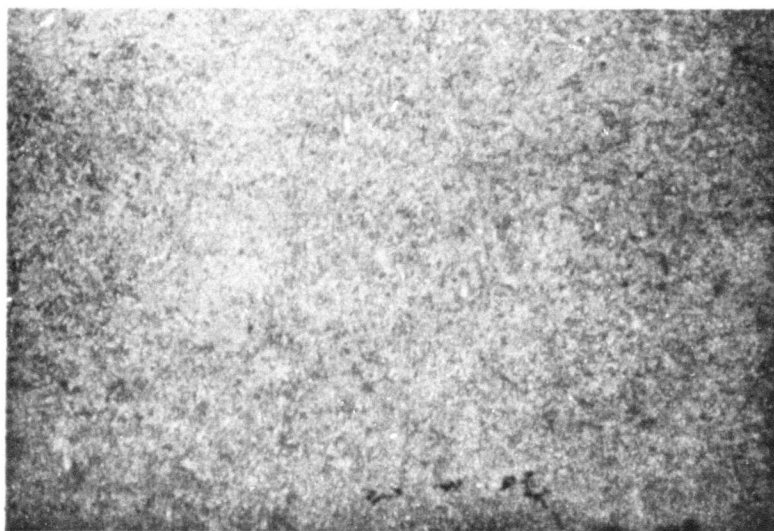
Figure 49. Core area 100X.

A photomicrograph, Figure 49, of the core area revealed a typical core structure for the type of heat treatment. The core structure consisted of a low-carbon, tempered martensite. No free ferrite was noted in the core structure; thus, it may be concluded that the quench rate was above the critical rate.

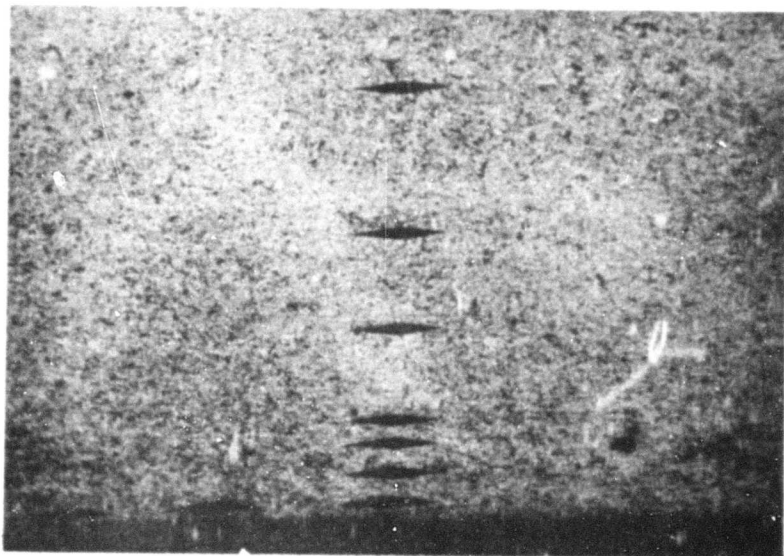
Figure 50. Unworn surface 100X.

The case, Figures 50 and 51, consisted of very fine tempered martensite platelets. A hardness survey was made using a Tukon hardness testing machine with a Knoop indenter and a 500-gram load.

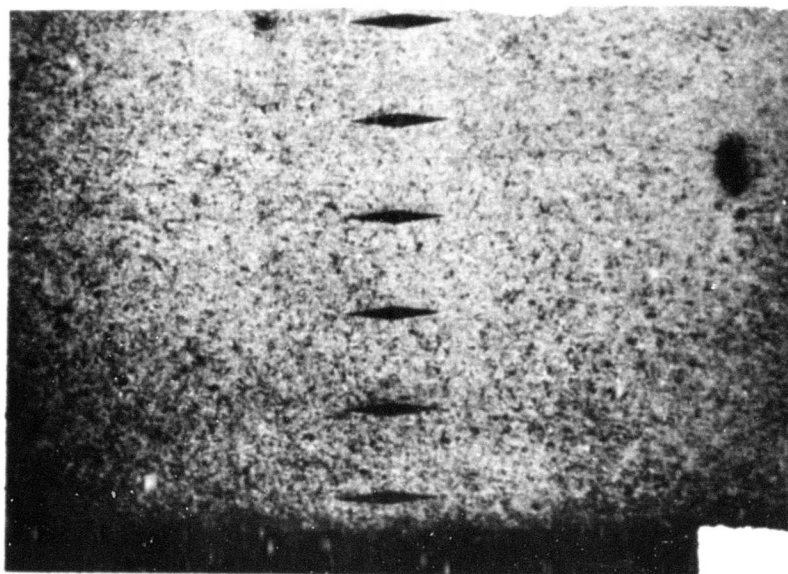
Figure 51. Worn surface 100X.

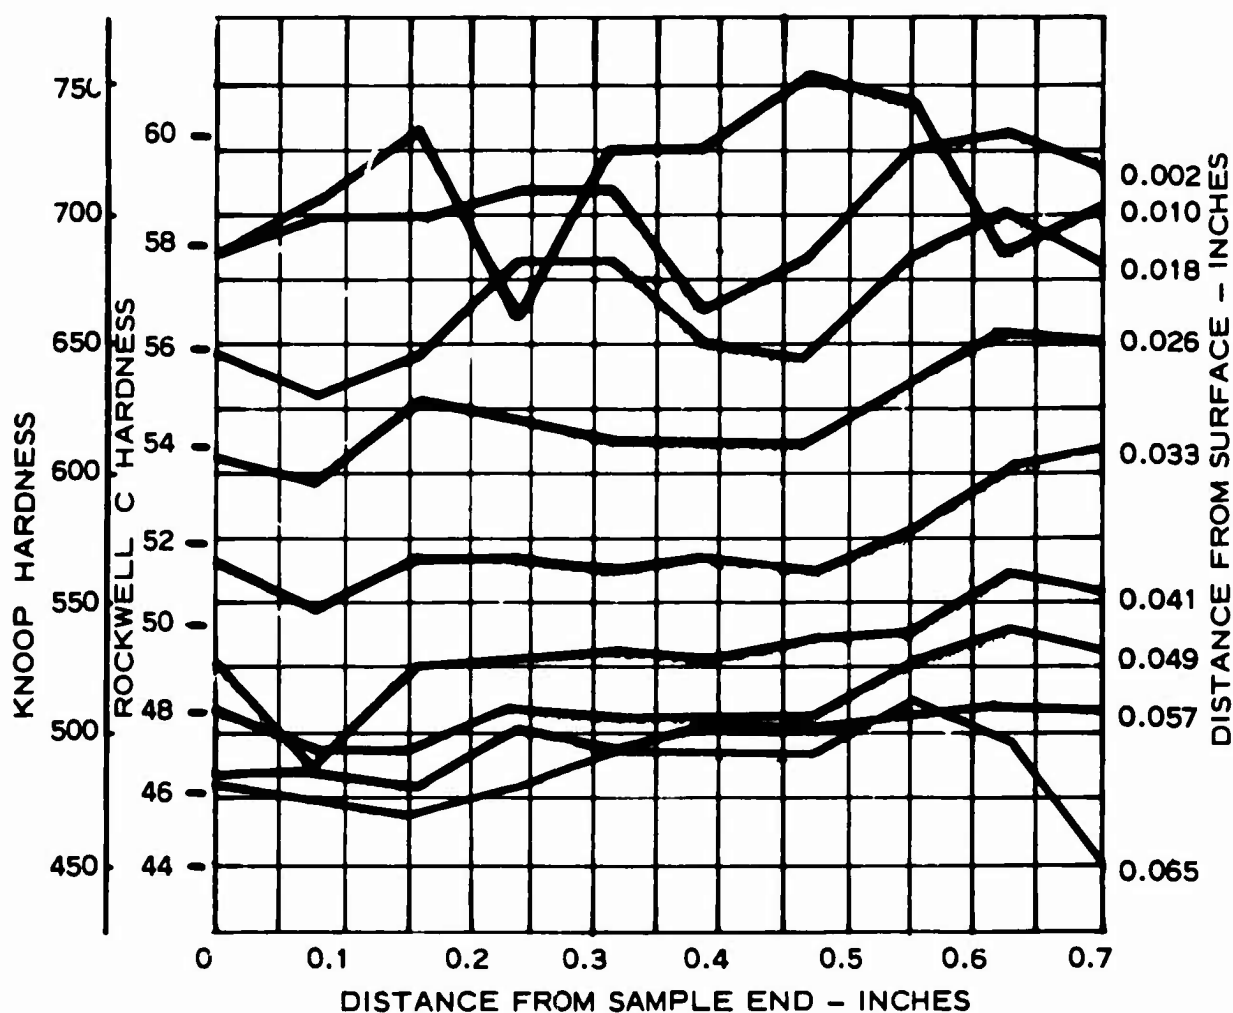
Figure 52. Hardness survey of crankshaft from transmission S/N 102. Material was SAE 4820 carburized casting with core hardness of 32 - 34 Rc.

The results of this survey may be found in Figure 52. Hardness measurements taken from the unworn surface show a hardness of Rockwell C 60 to 62 approximately 0.002 inch below the surface. At a distance of 0.025 inch below the surface, the hardness was Rockwell C 56. The case hardness dropped below Rockwell C 50 at approximately 0.047 inch. Core hardness measured on the Rockwell A scale and converted to Rockwell C was 32 to 34.

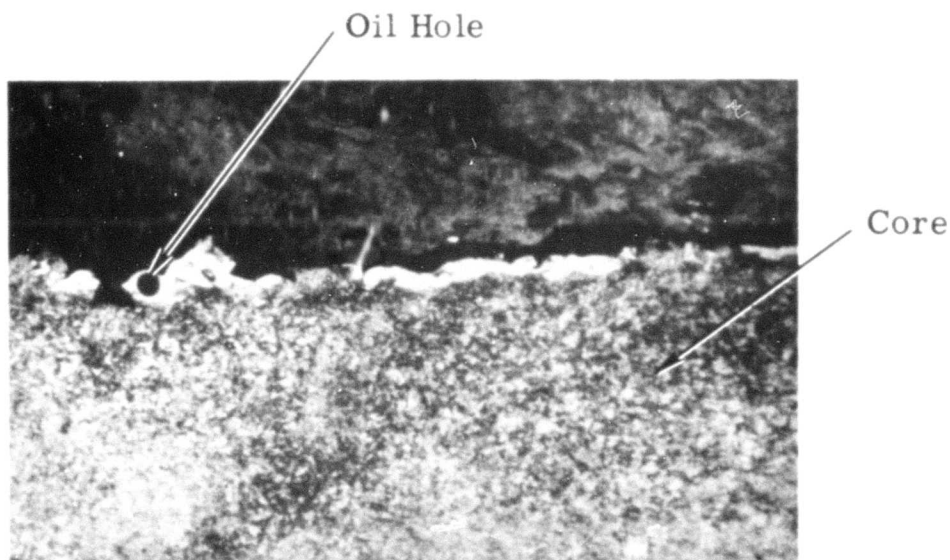
Figure 53. Oil hole and core 100X.

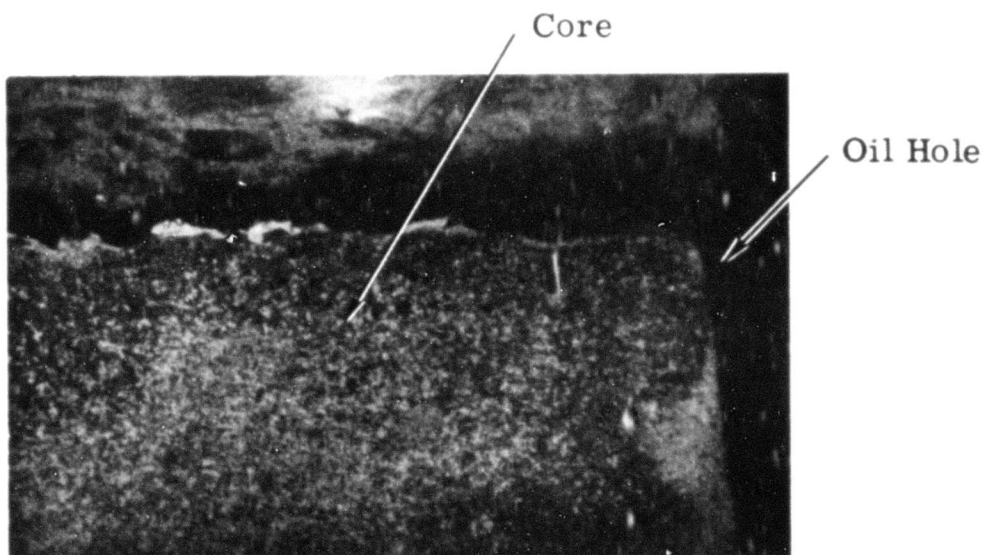
Figure 54. Oil hole and core 100X.

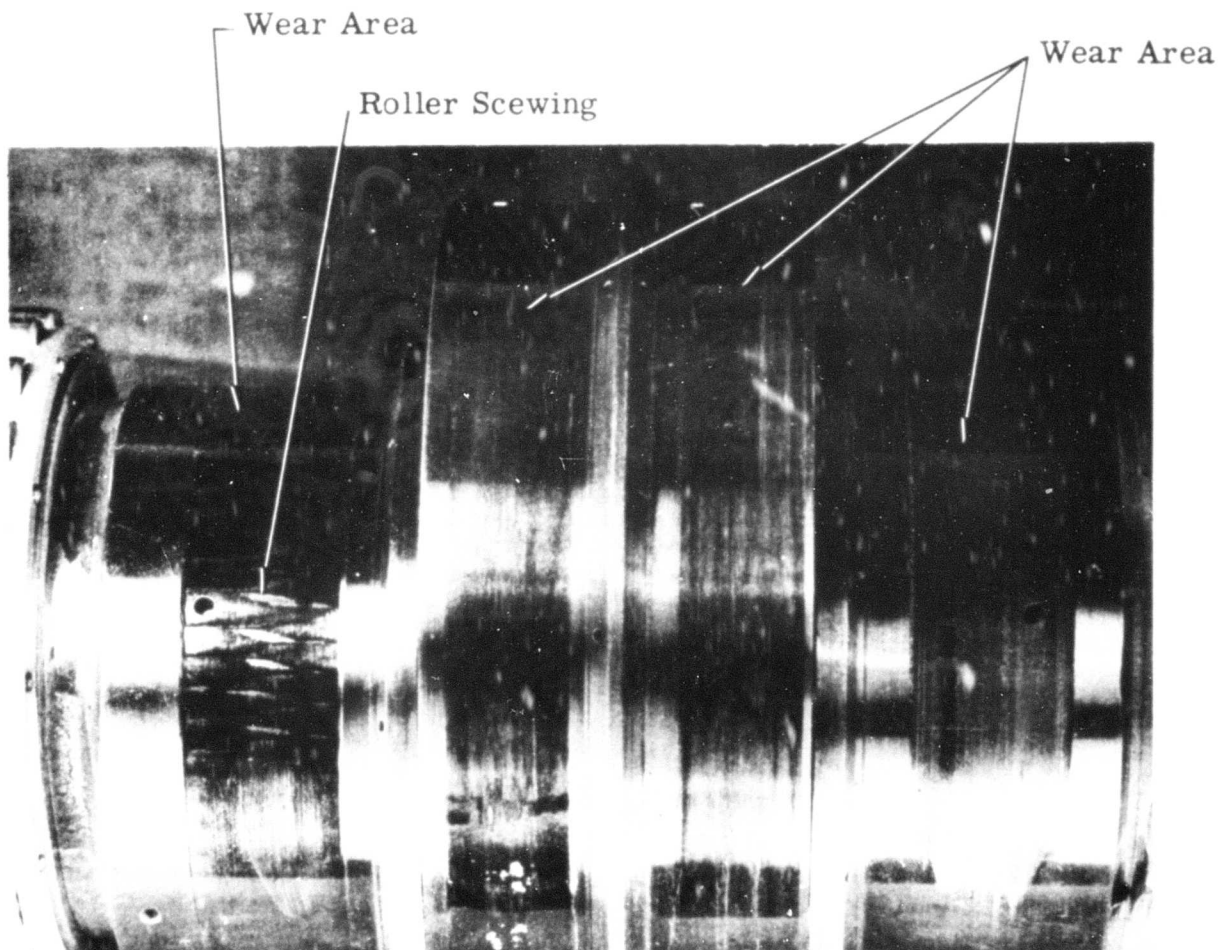
Figure 56. Crankshaft from transmission S/N 102.

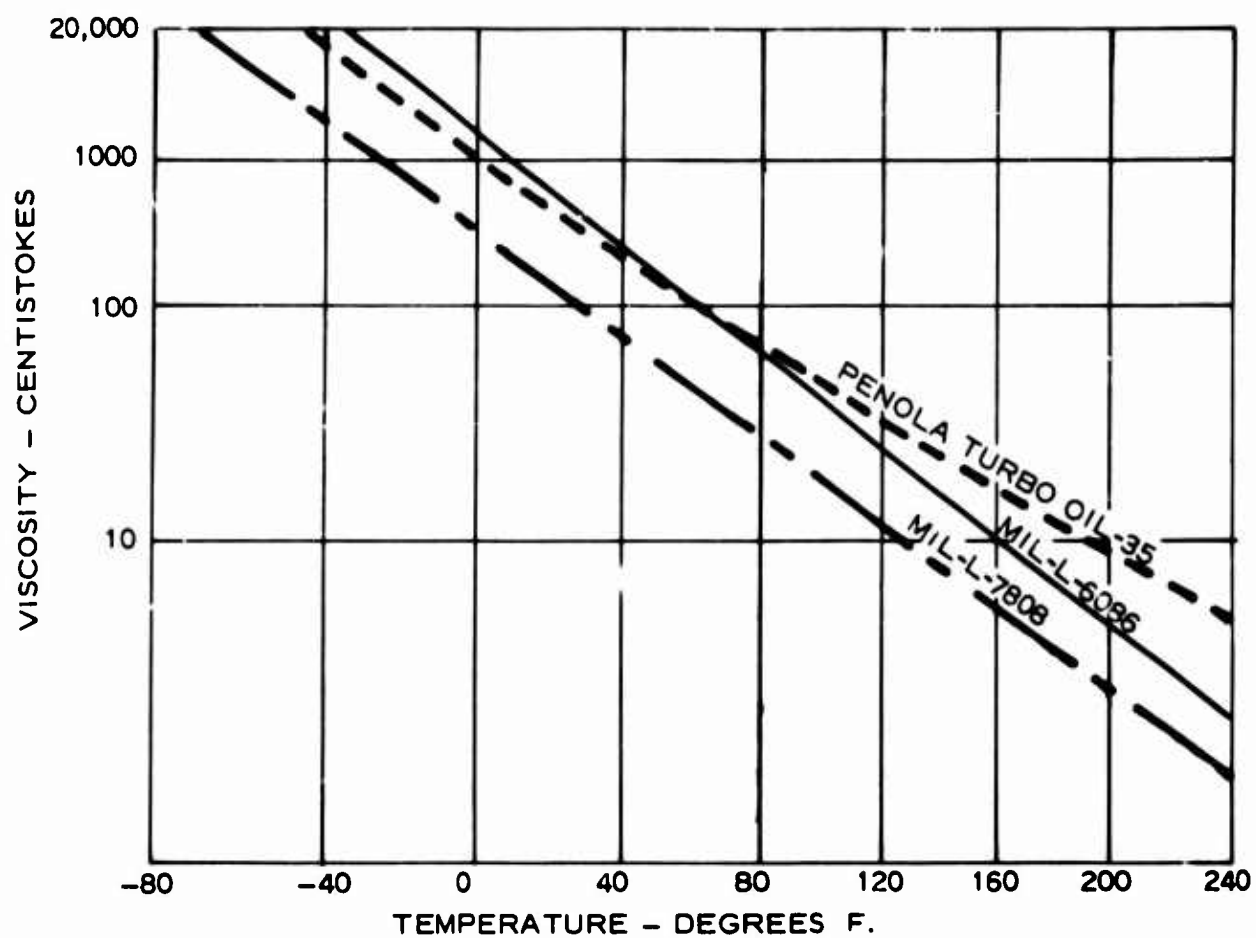
Figure 57. Viscosity versus temperature graph for three transmission lubricants.
